Operating Experience Weekly Summary 97-52

December 19 through December 25, 1997

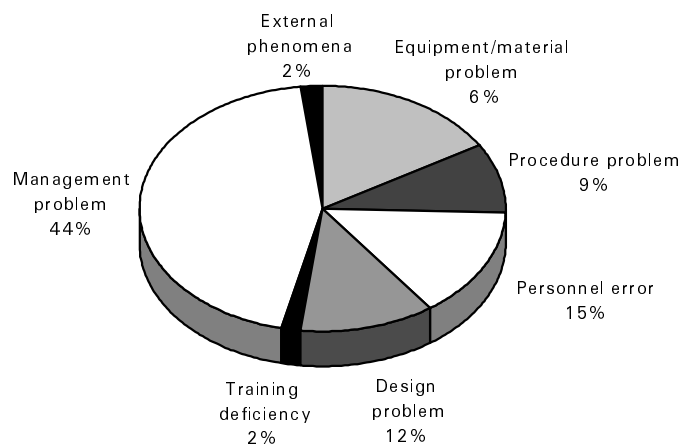
OEAF engineers searched the ORPS database for events with a nature of occurrence of safety status degradation and found 1,521 events. Figure 2-1 shows the root causes for these events. A review of these occurrences shows that managers reported 44 percent of the root causes as management problems, with 38 percent attributed to inadequate administrative control and 24 percent attributed to policy not adequately defined, disseminated, or enforced.

Figure 2-1. Root Causes for Safety Status Degradation¹

¹ OEAF engineers searched the ORPS database using the graphical user interface for reports with a nature of occurrence code "1C" (safety status degradation) and found 1,521 events for which a root cause had been identified.

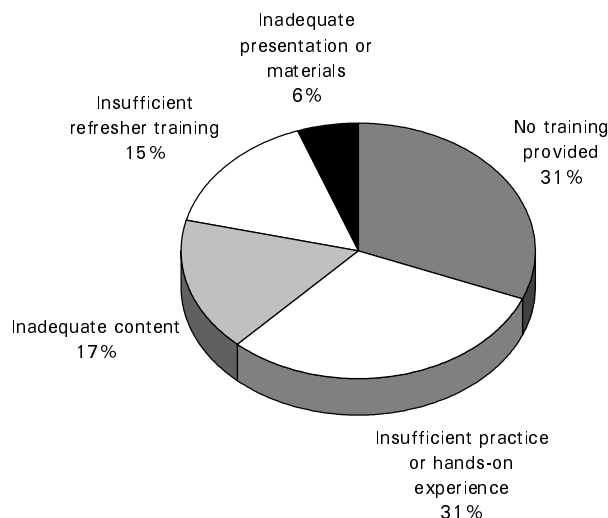
OEAF engineers searched the ORPS database for all events that involved training as the root, direct, or contributing causes and found 2,869 reports. Figure 1-1 shows the distribution of the training deficiencies for these events. A review of these occurrences shows that facility managers reported 31 percent of the occurrences as no training provided; insufficient practice or hands-on experience accounted for an additional 31 percent.

Figure 1-1. Training Deficiency Distributions¹

¹ OEAF engineers searched the ORPS database using the graphical users interface for reports with a root cause code "5A" (no training provided) OR a direct cause code "5A" OR a contributing cause code "5A" AND a root cause code "5B" (insufficient practice or hands-on experience) AND a direct cause code "5B" OR a contributing cause code "5B" AND a root cause code "5C" (inadequate content) OR a direct cause code "5C" OR a contributing cause code "5C" AND a root cause code "5D" (insufficient refresher training) OR a direct cause code "5D" OR a contributing cause code "5D" AND a root cause code "5E" (inadequate presentation or materials) OR a direct cause code "5E" OR a contributing cause code "5E" and found 2,869 reports.
